OMEGA ZONE 8, ST HELENS

Ground Investigation Report
& Remediation Strategy
Appendix B & C
OPP DOC. 2.4

COAL AUTHORITY REPORT

Omega West, Warrington – UXO Desk Study & Risk Assessment

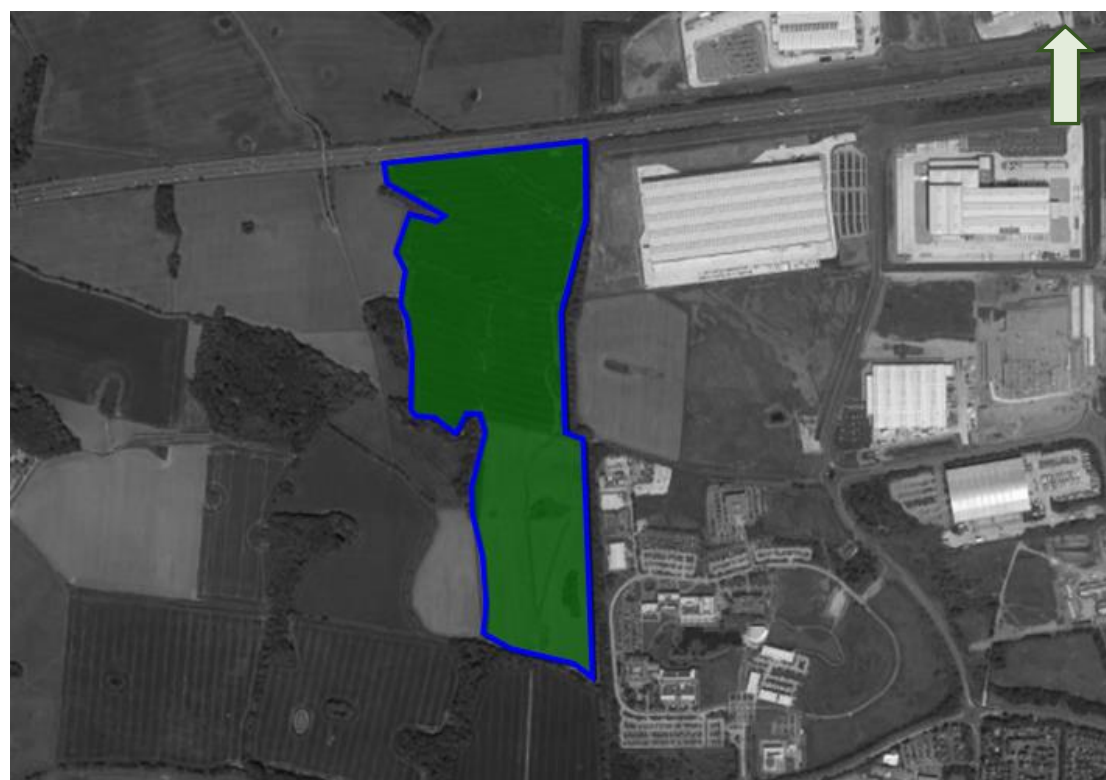
Figure UXO hazard zone plan of the Site

No records have been found indicating that the Site was bombed and no other significant sources of UXO hazard have been identified on the Site.

Given this, it is considered that the Site has a low UXO hazard level, as shown in the following Figure, reproduced as Figure 6 in the main report.

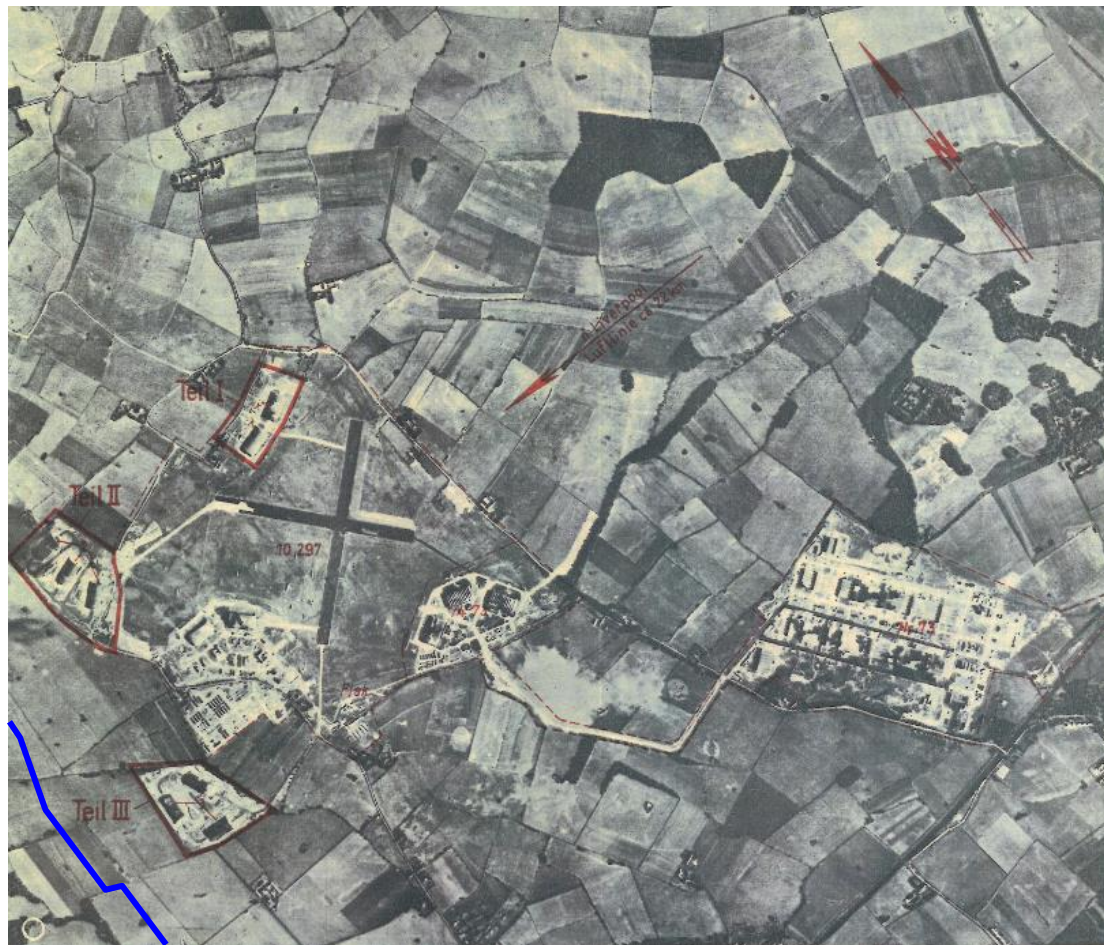
Plate 4 Luftwaffe target photograph of Burtonwood, 17th September 1940

Plate 4 is a Luftwaffe target photograph of Burtonwood, dated the 17th September 1940. It identifies Burtonwood Airfield (GB 10 297), associated aircraft warehouses (Teil I, Teil II and Teil III) and manufacturing and repair depots (GB 74 73).

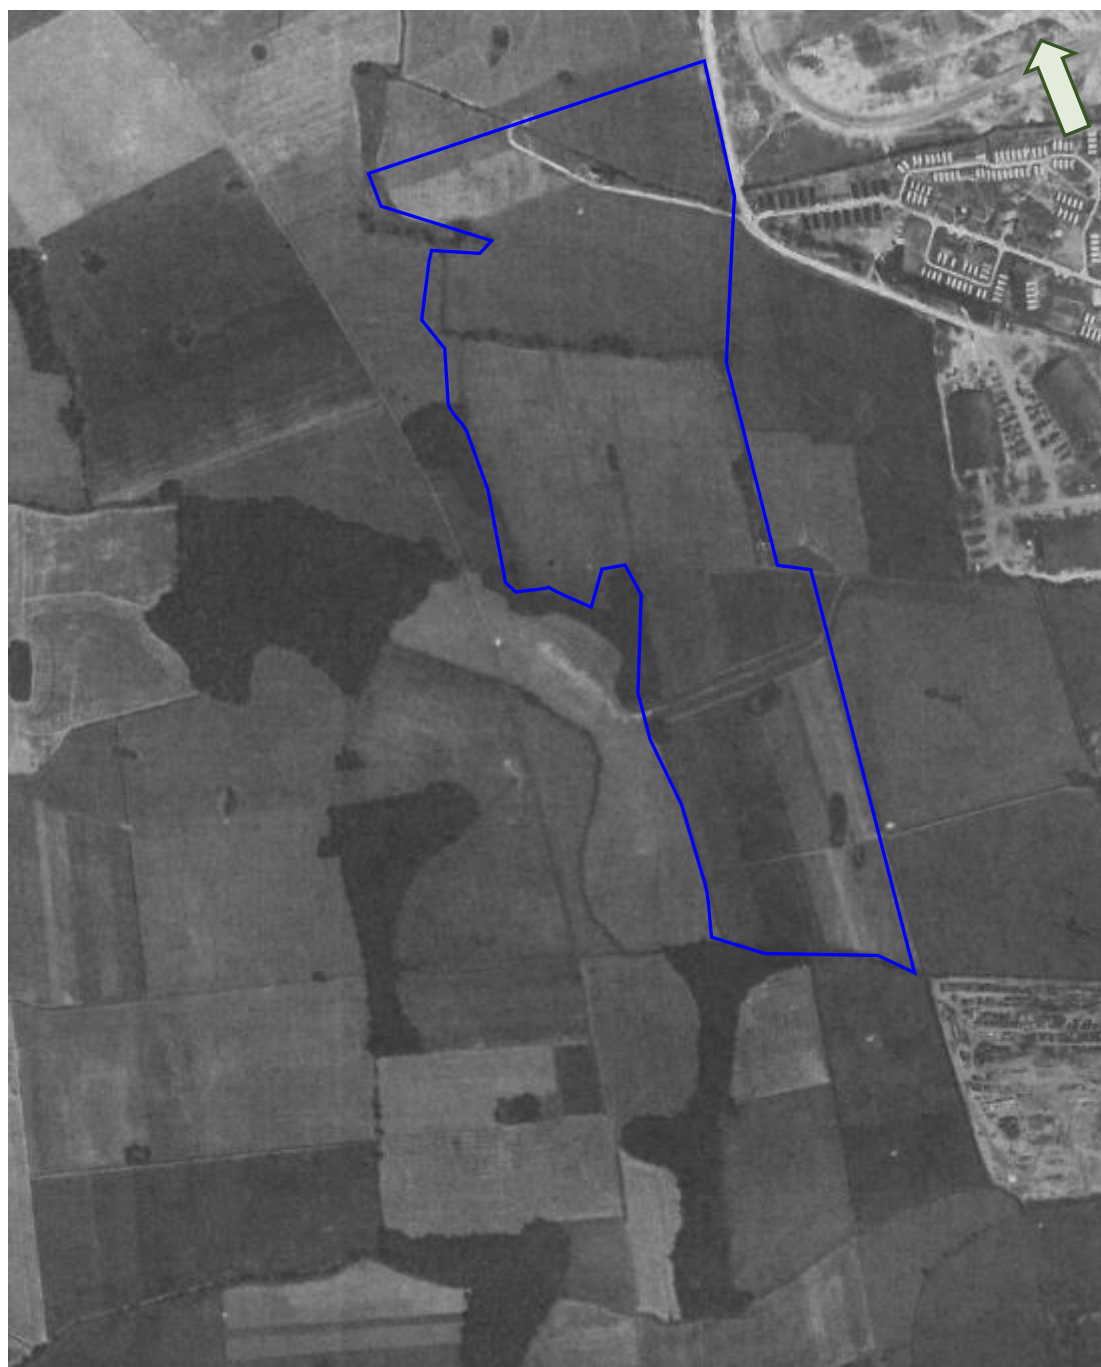
Plate 5 is an aerial photograph dated the 10th August 1945. No bomb damage has been identified on or in close proximity to the Site.

Aerial photograph, 10th August 1945

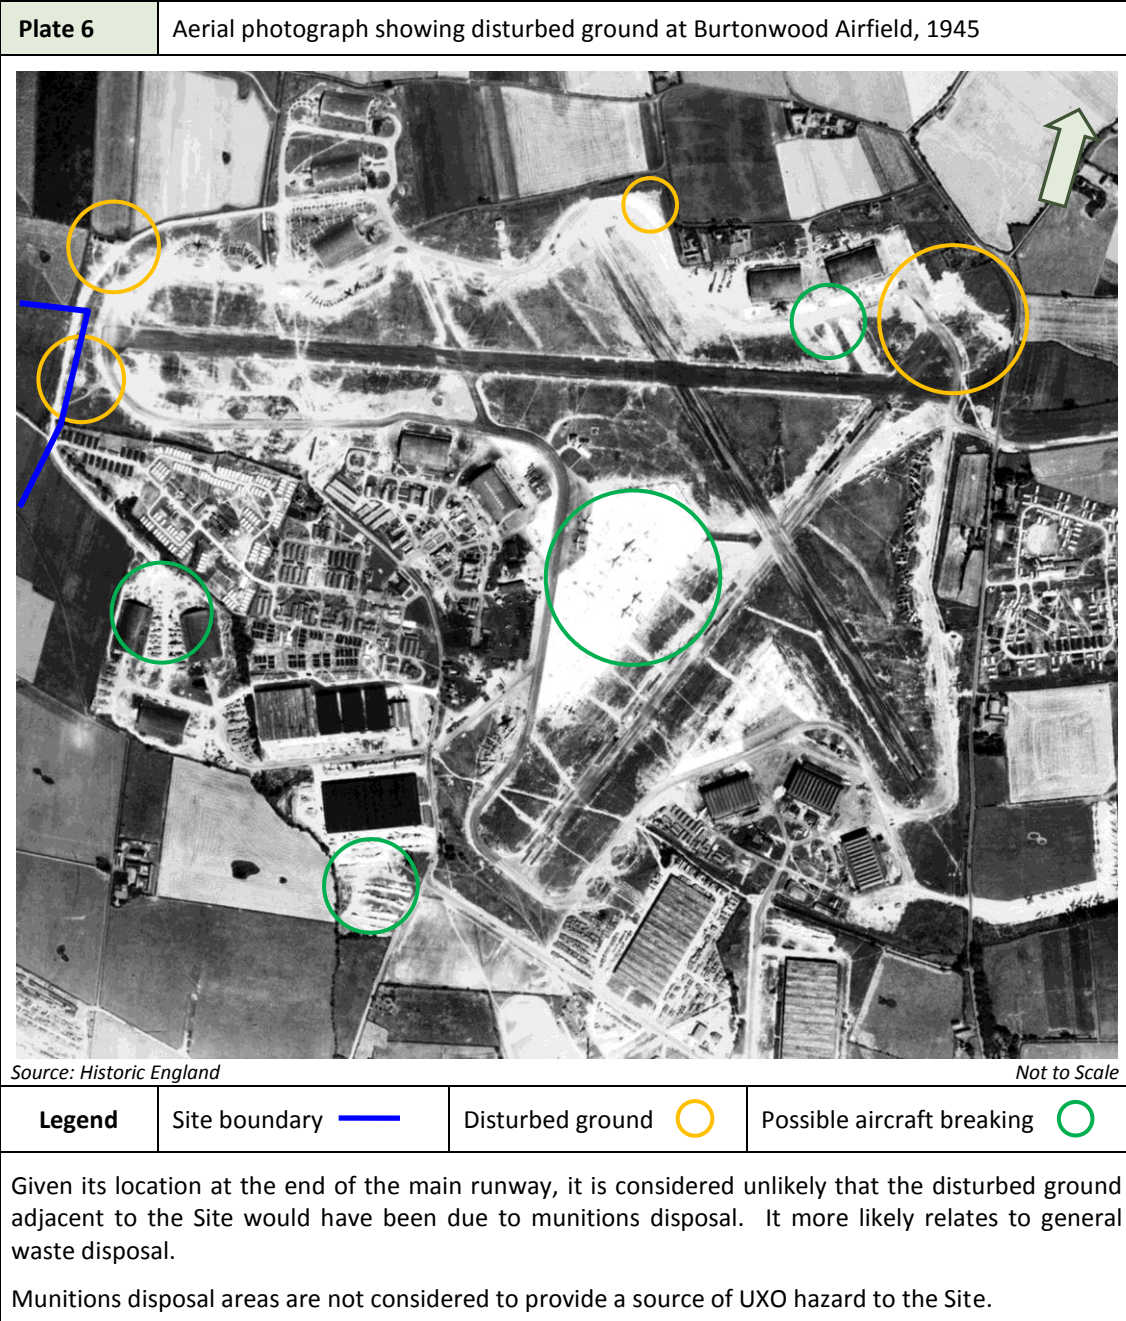
Plate 6 is an aerial photograph, dated the 10th August 1945, showing large areas of disturbed ground around the airfield, typical of waste burial. The nearest of these was located adjacent to the north-eastern corner of the Site.

A variety of aircraft, many awaiting scrapping, are also evident around the airfield. There is evidence of possible aircraft breaking near the G-site hangars, approximately 0.3km east of the Site.

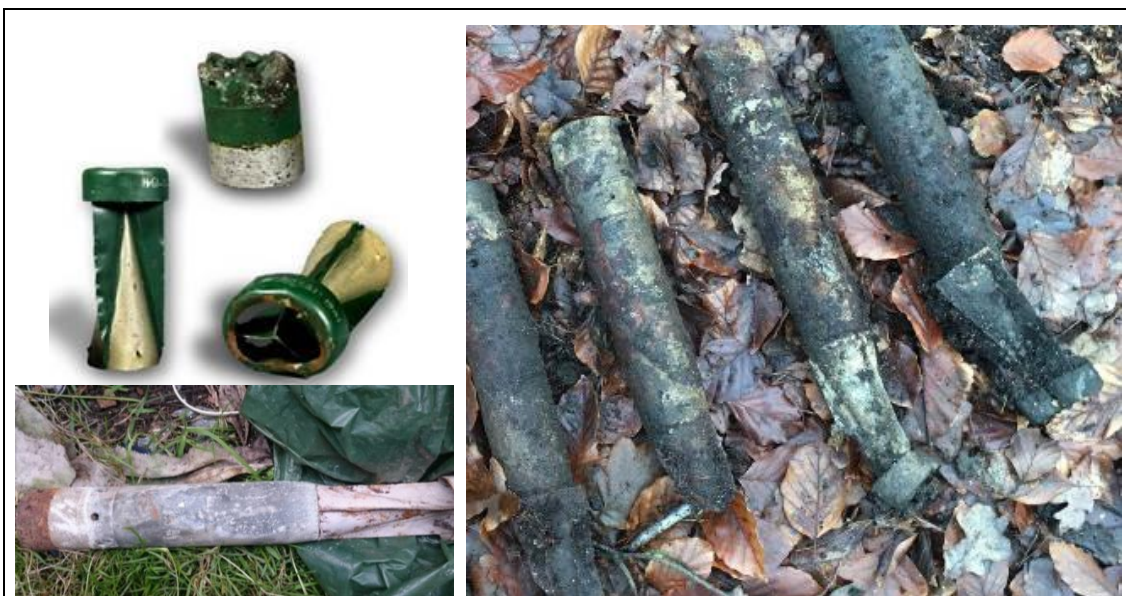
The Plate below shows a typical variety of fragmentary remains of IBs and IBs recovered by the Civil Defence during WWII, along with a photograph of 4No. spent IBs found in Hertfordshire in January 2017 (lower right).

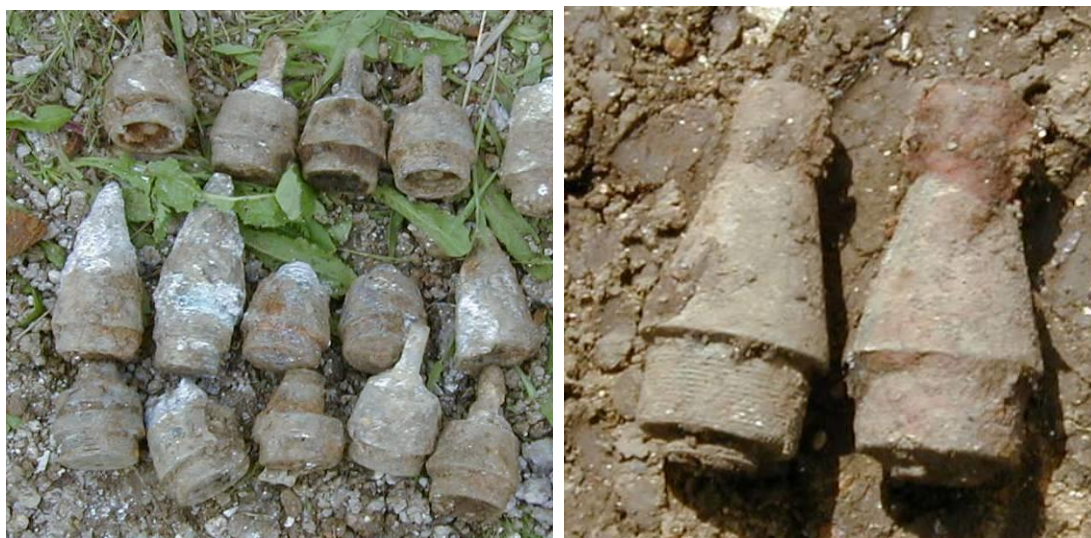
A wide variety of these components were used and examples of some common fuzes are shown in the Plate below.

Plate	Photographs showing examples of WWII fuzes
-------	--

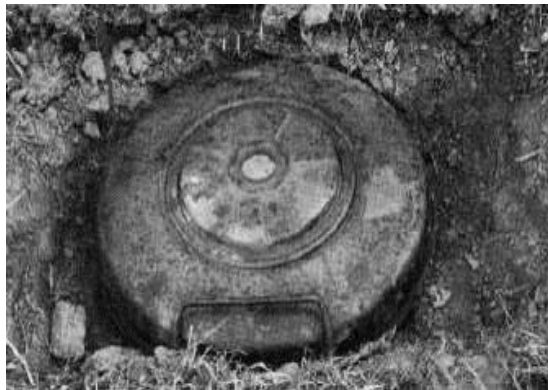
Plate

Photographs of original and recently excavated WWII land mines

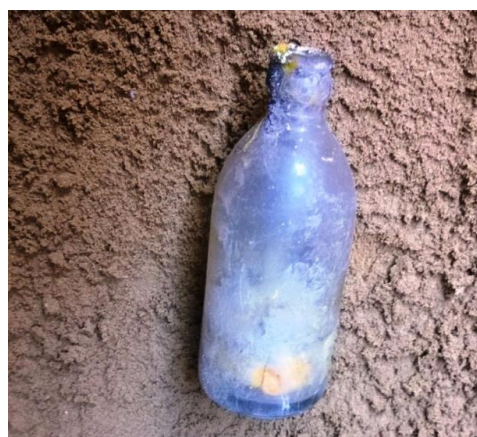
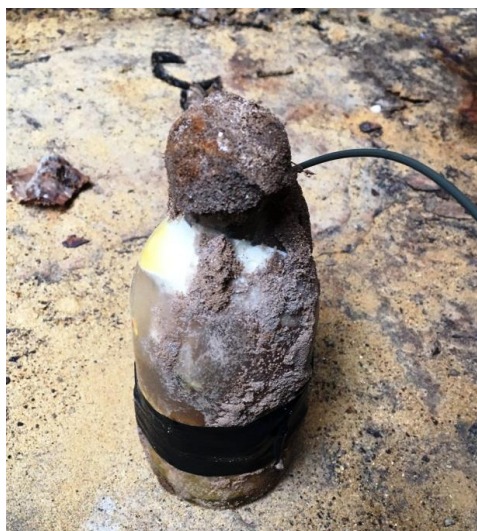
The Plate below is a photograph of a No. 76 SIP grenade (LHS) with an explanatory leaflet produced by ZeticaUXO for site staff (RHS).

Plate Photographs of No. 76 SIP grenades
