OMEGA ZONE 8, ST HELENS

Omega St Helens Ltd / T. J. Morris Limited

Document Title
ES Vol. 2 Appendix 1.1
EIA Scoping Report
Document No. OPP DOC.11.18e

**BGS BOREHOLE LOG AND COAL
AUTHORITY REPORT**

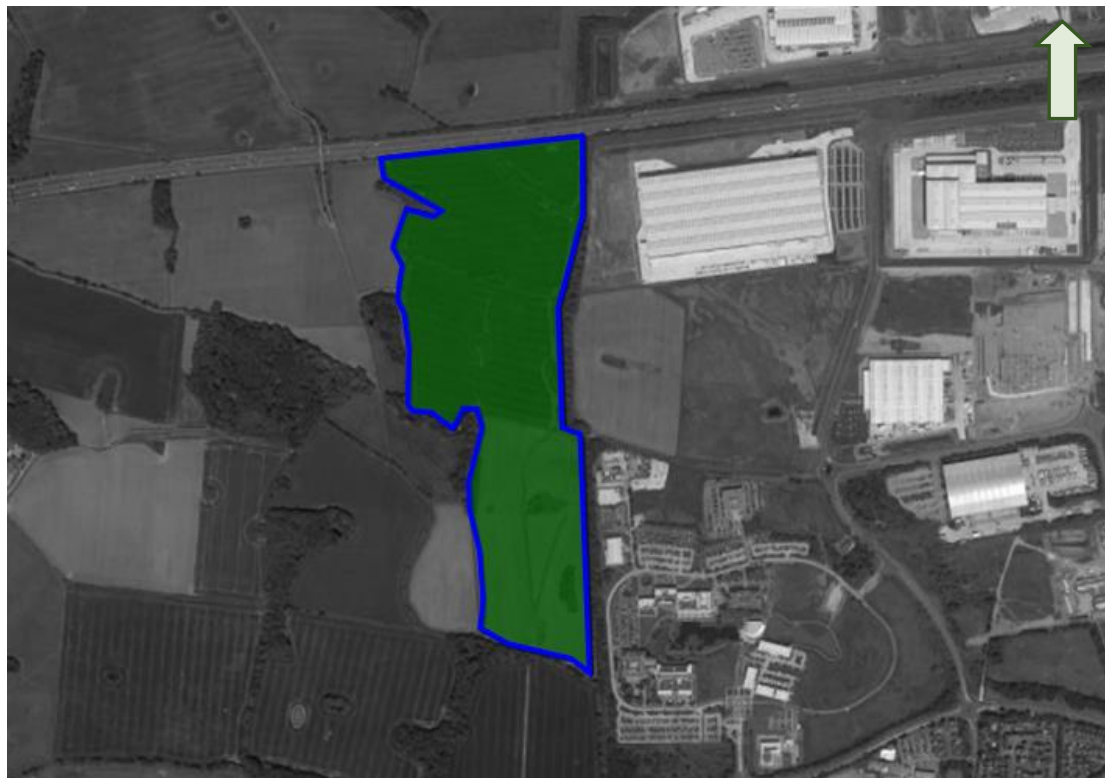
Figure UXO hazard zone plan of the Site

Given this, it is considered that the Site has a low UXO hazard level, as shown in the following Figure, reproduced as Figure 6 in the main report.

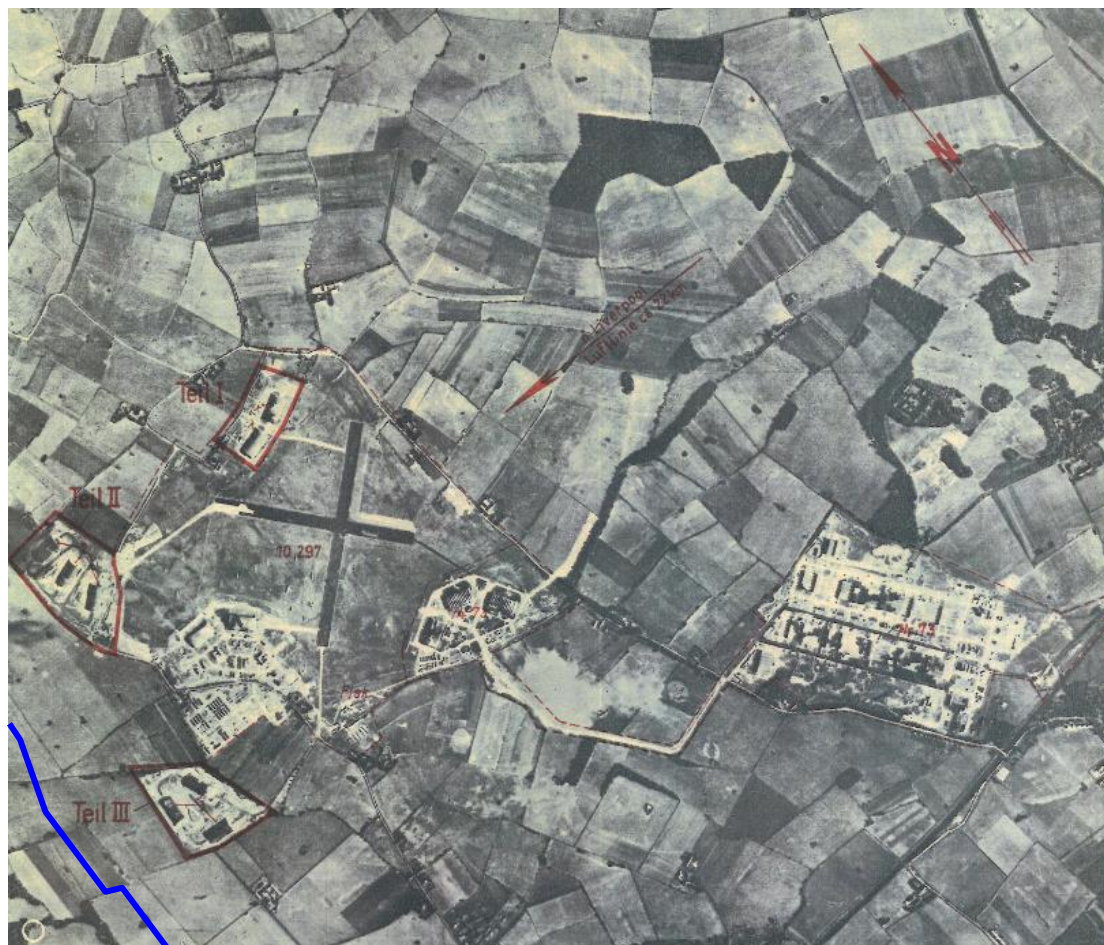
Plate 4 Luftwaffe target photograph of Burtonwood, 17th September 1940

Plate 4 is a Luftwaffe target photograph of Burtonwood, dated the 17th September 1940. It identifies Burtonwood Airfield (GB 10 297), associated aircraft warehouses (Teil I, Teil II and Teil III) and manufacturing and repair depots (GB 74 73).

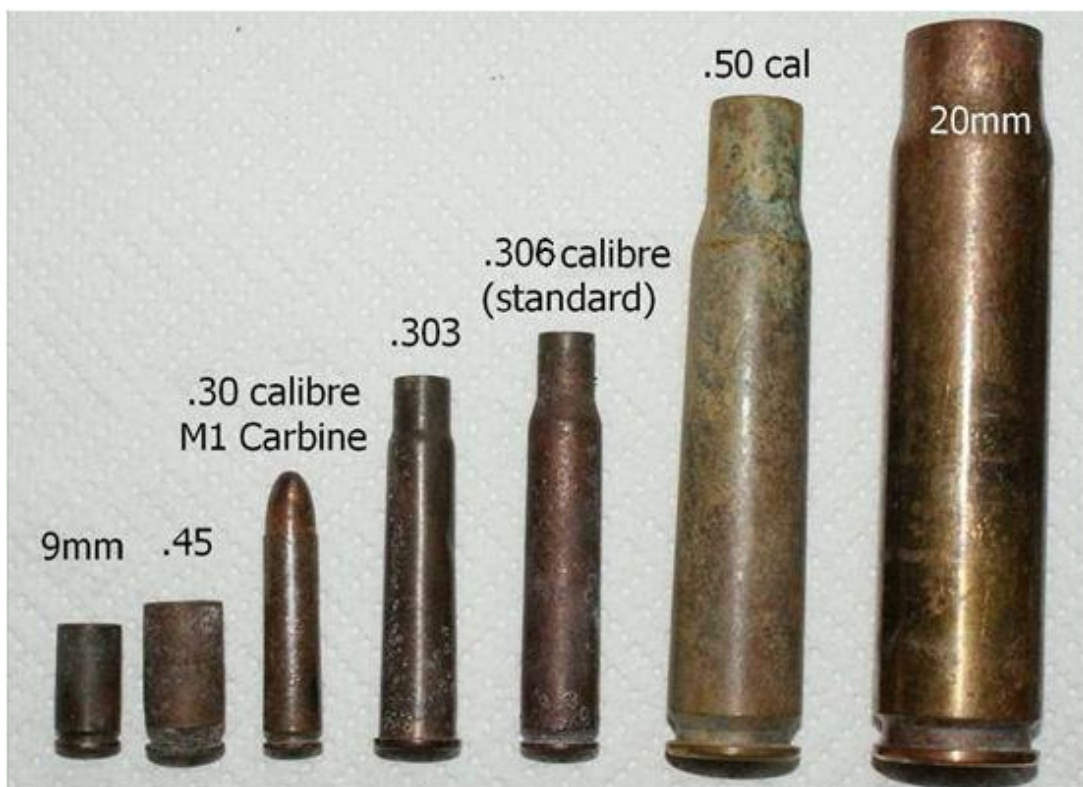
Generally small arms ordnance has a relatively low risk as UXO, although the larger calibre categories may have the same detonation risk as larger high explosive ordnance. SAA is often associated with discarded ammunition boxes around firing practice ranges. The Plate below illustrates some common SAA.

Plate Photograph of typical WWII small arms ammunition

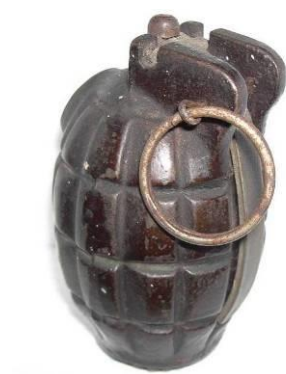
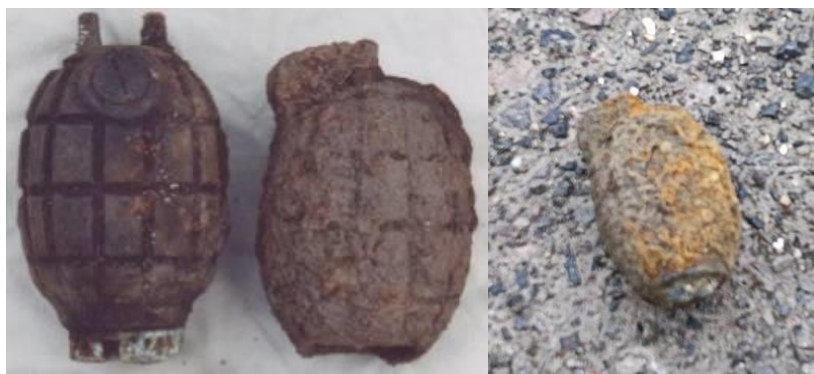
Some, such as smoke grenades, are activated instantly when the lever is released. The Plate below illustrates the typical character and condition of No. 36 hand grenades (Mills Bombs) that have been excavated from a site.

Plate	Photographs of a typical and an excavated WWII No. 36 hand grenades
--------------	---

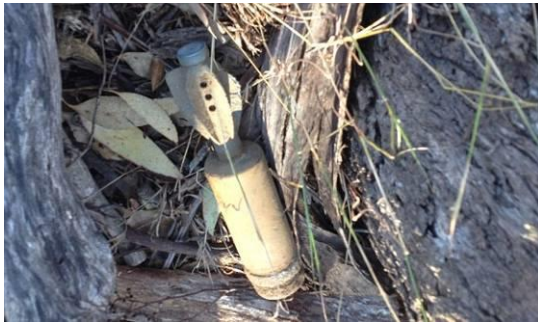
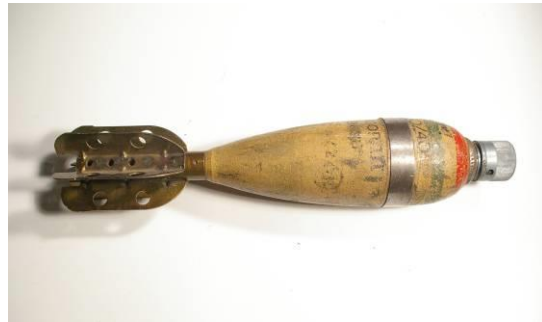
The Plate below shows a typical 2-inch mortar bomb found (left) and a demonstration 3-inch mortar bomb (right).

Plate	Photographs of WWII 2-inch and 3-inch mortars
--------------	---

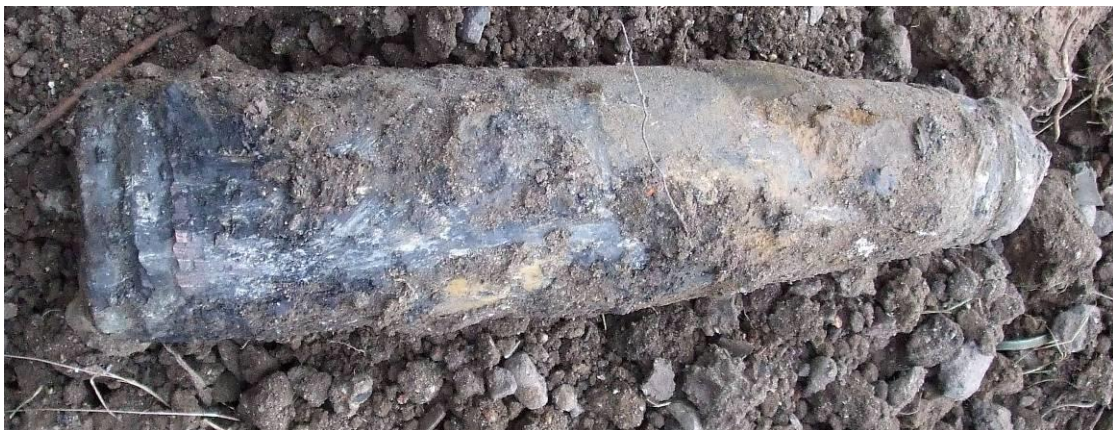
The Plate below is a photograph of a 3.7" UXAA shell found in Camberwell, London.

Plate	Photograph of a recently excavated 3.7" AA shell
--------------	--

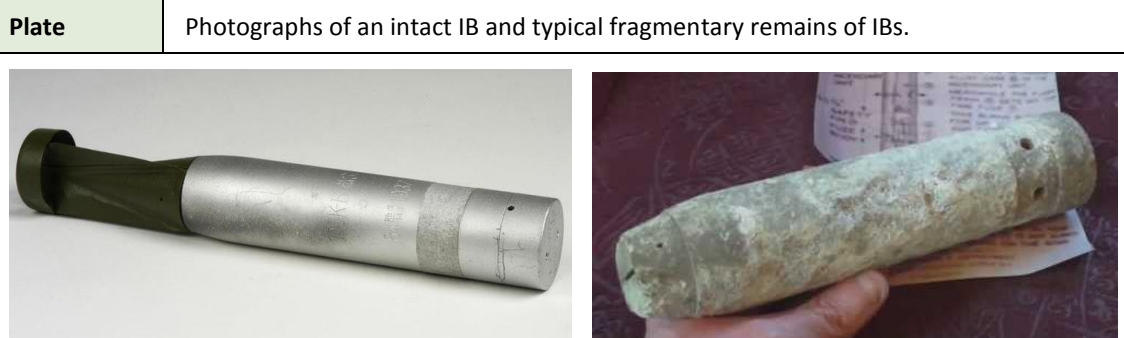
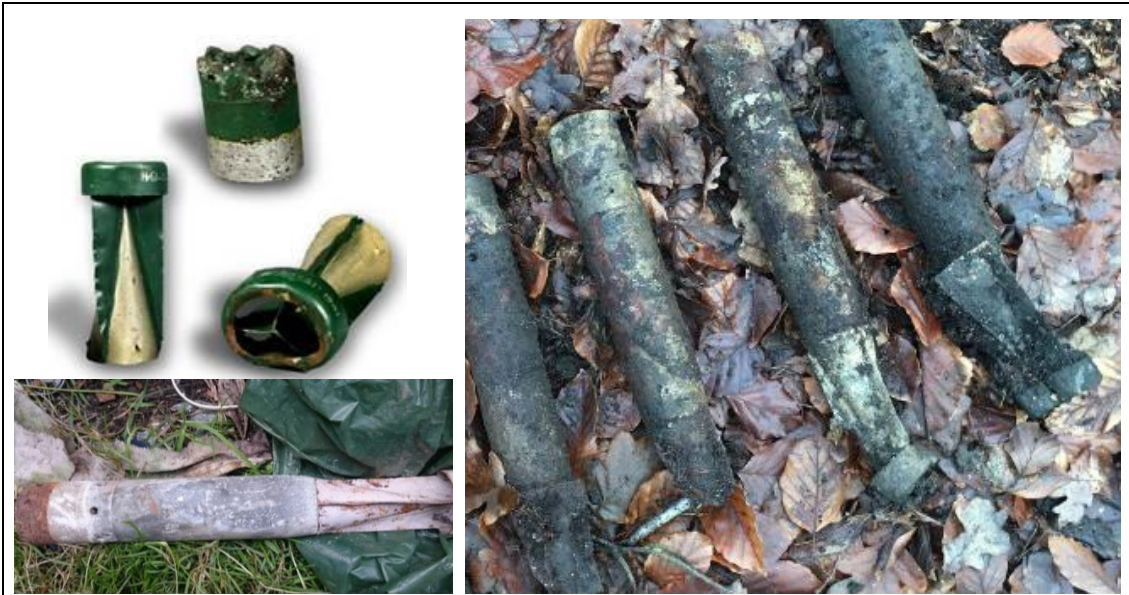
The Plate below shows a typical variety of fragmentary remains of IBs and IBs recovered by the Civil Defence during WWII, along with a photograph of 4No. spent IBs found in Hertfordshire in January 2017 (lower right).

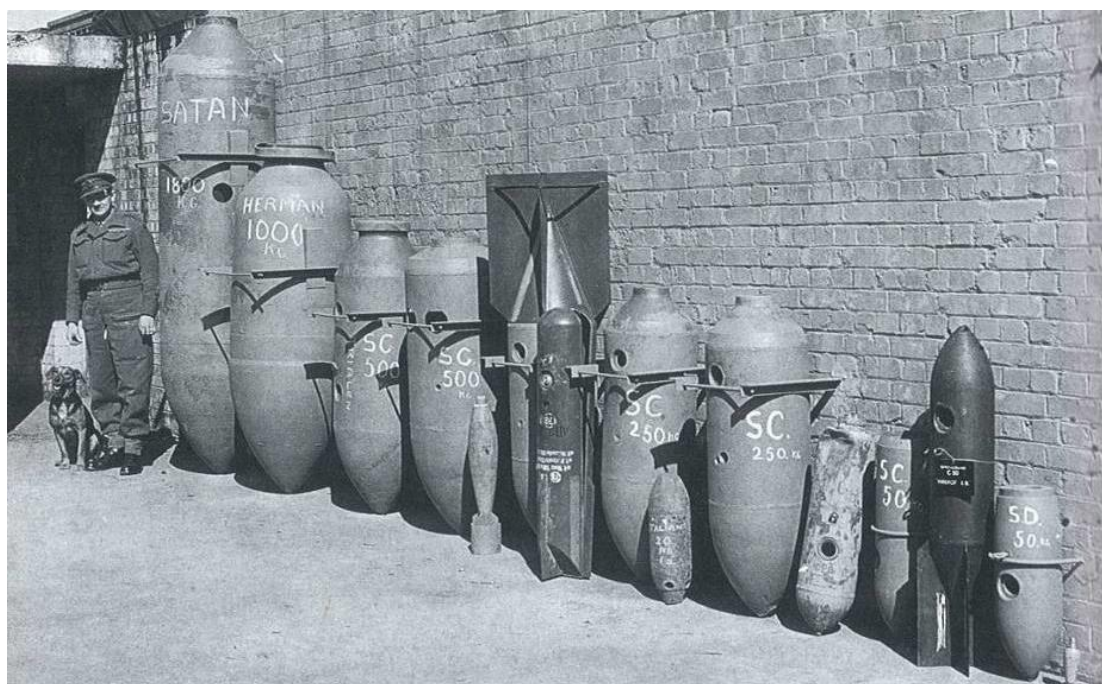
The Plate below shows the variety of UXB recovered by the Civil Defence during WWII.

Plate	Photograph of a variety of UXB recovered by the Civil Defence during WWII
--------------	---

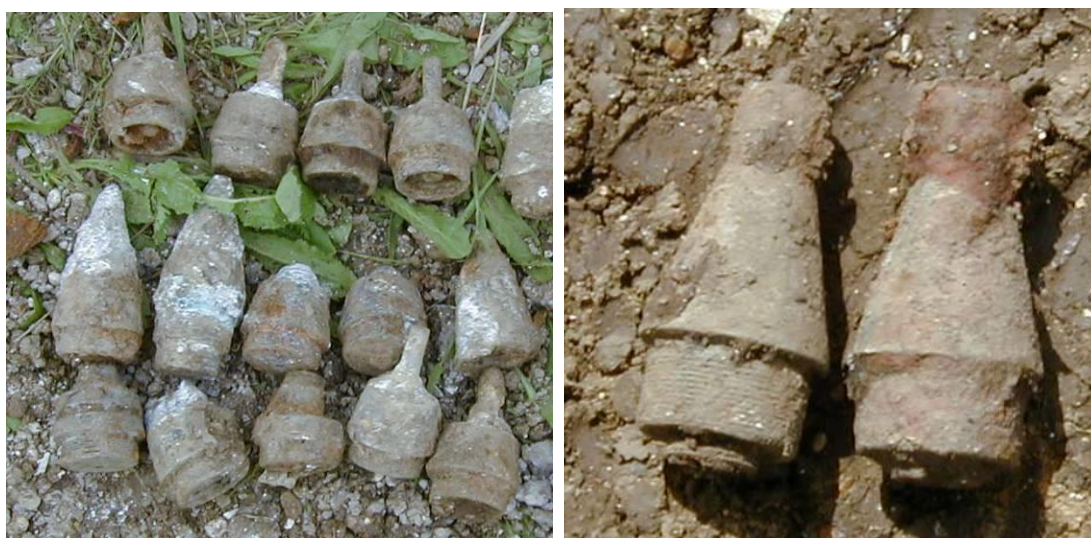
A wide variety of these components were used and examples of some common fuzes are shown in the Plate below.

Plate	Photographs showing examples of WWII fuzes
--------------	--

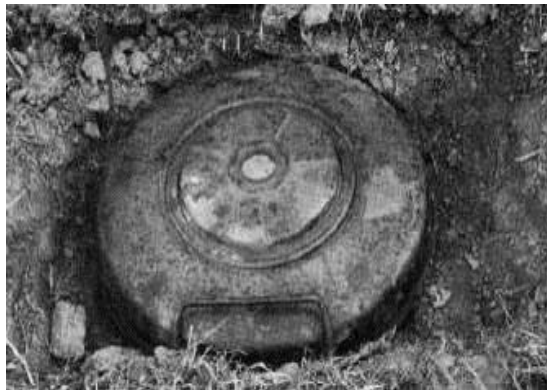
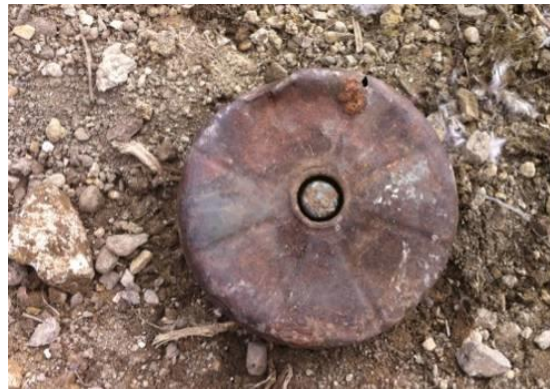
Plate

Photographs of original and recently excavated WWII land mines

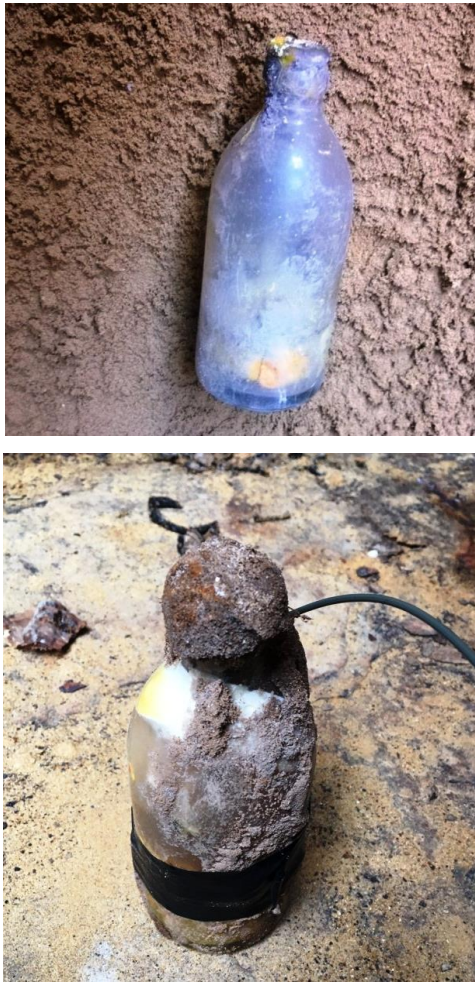
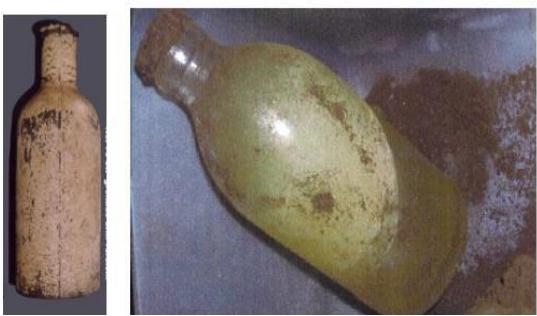
The Plate below is a photograph of a No. 76 SIP grenade (LHS) with an explanatory leaflet produced by ZeticaUXO for site staff (RHS).

Plate	Photographs of No. 76 SIP grenades

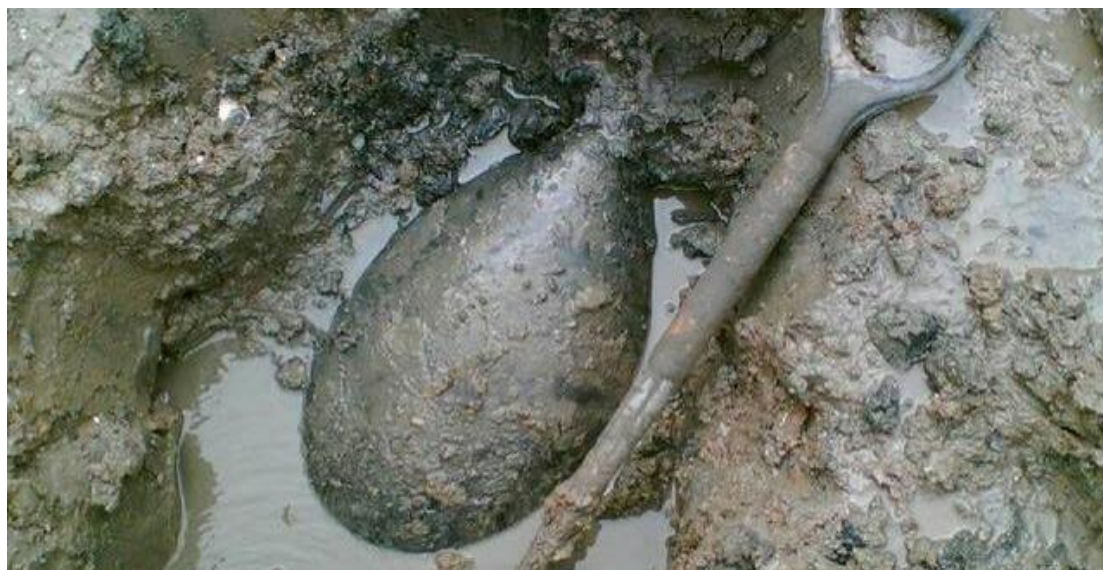
The Plate below is a photograph of the bomb in situ.

Plate	Photograph of the 500kg WWII UXB at Bowers Marsh, 8 th March 2010
--------------	--

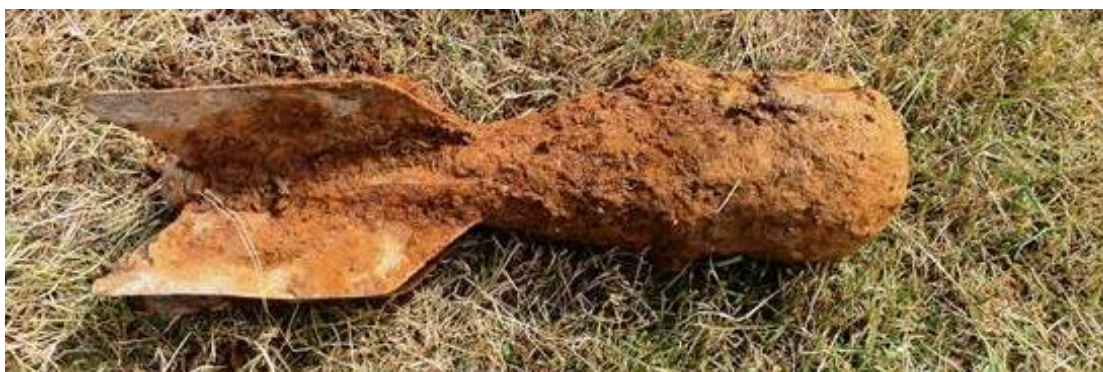
1No. WWI bomb (shown in the Plate below) was found on the Isle of Sheppey on the 2nd August 2012 during a geophysical survey following desk study research by Zetica Ltd which had established that a previously unknown WWI bombing range existed on the site. A further WWI bomb was found in the same location in August 2015.

Plate	Photograph of WWI bomb, Isle of Sheppey, 2 nd August 2012
--------------	--

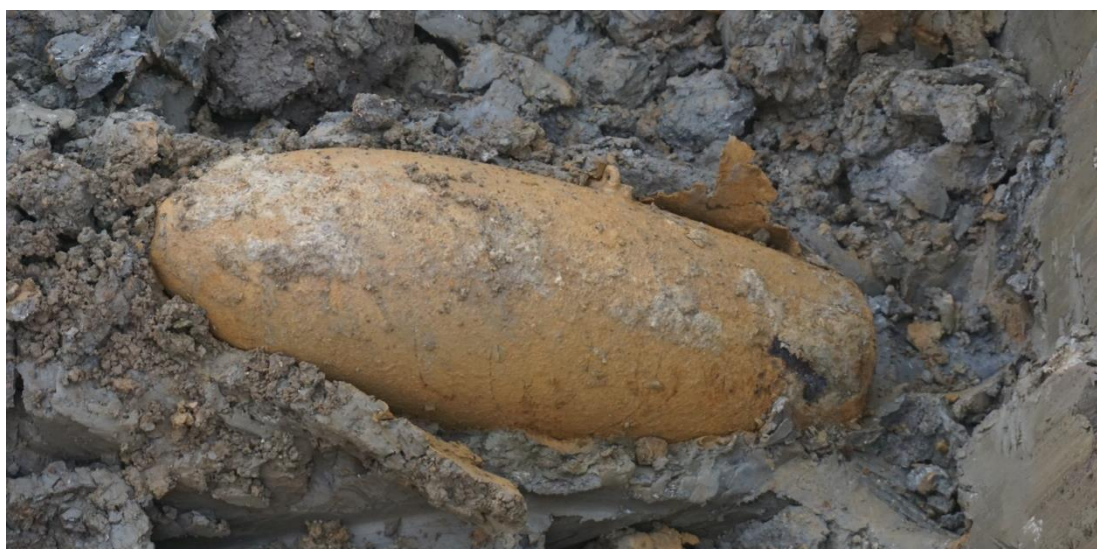
In January 2016, Zetica discovered 3No. 500lb British UXB at a former airfield in Cambridgeshire. These were destroyed in controlled explosions. The Plate below is a photograph of one of the bombs.

Plate Photograph of a recently excavated WWII British 500lb GP bomb

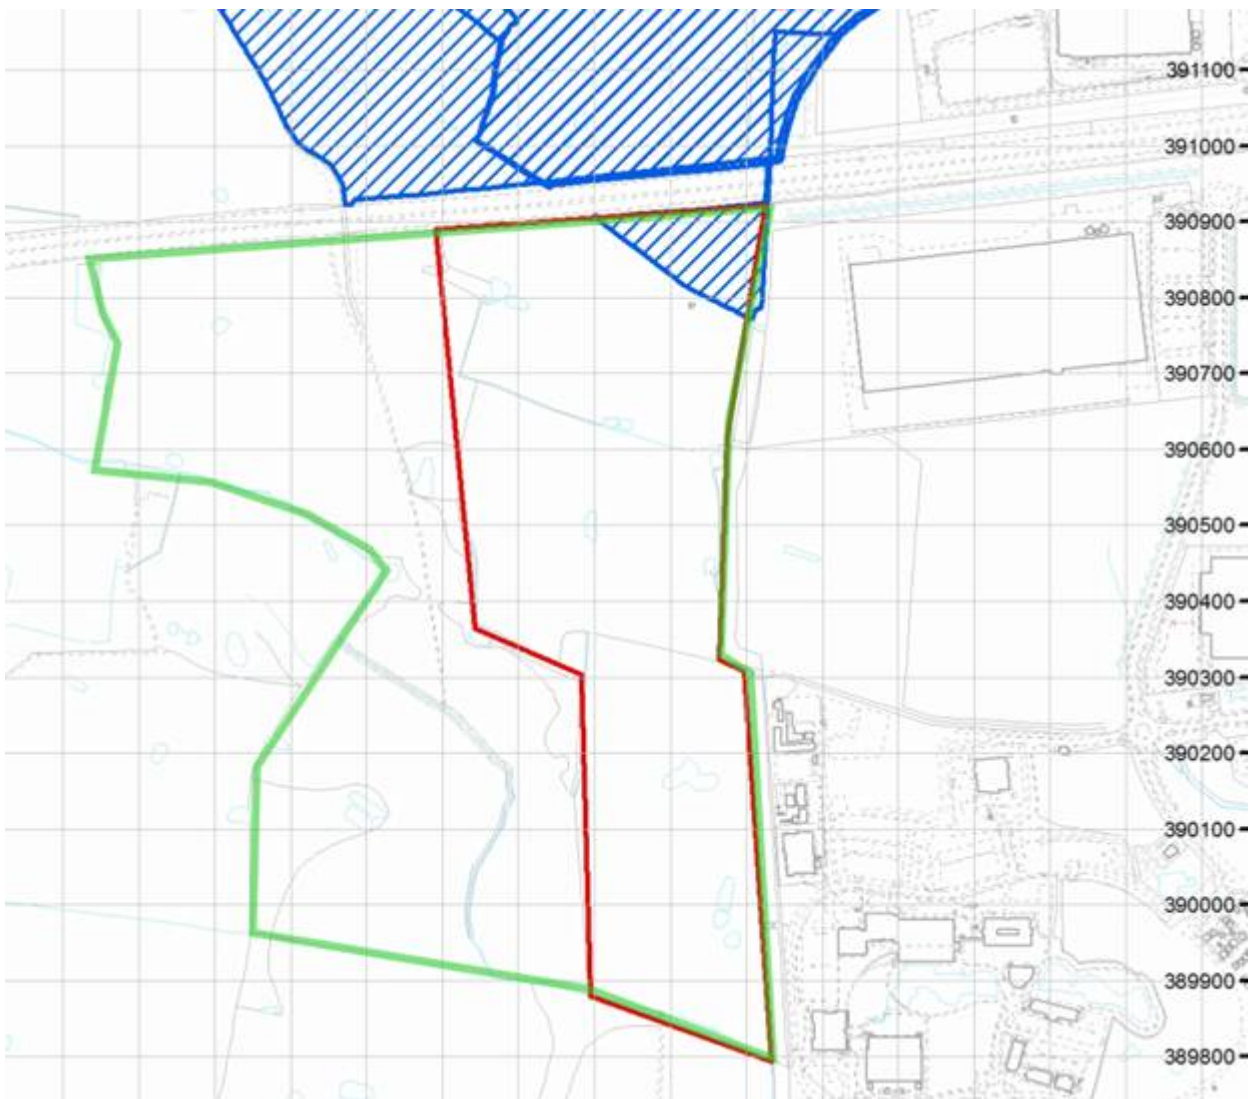
We have currently made a recent purchase of a UXO Desk Study for the Omega West site (ref: P7831-18-R1). We have recently been informed by our client that the boundary has changed to the following (shown in green): Are you able to confirm if the findings from the original UXO report are still valid for the additional search area?
