# OMEGA ZONE 8, ST HELENS

Omega St Helens Ltd / T. J. Morris Limited

Ground Investigation Report  
& Remediation Strategy  
Appendix A continued  
OPP DOC. 2.3

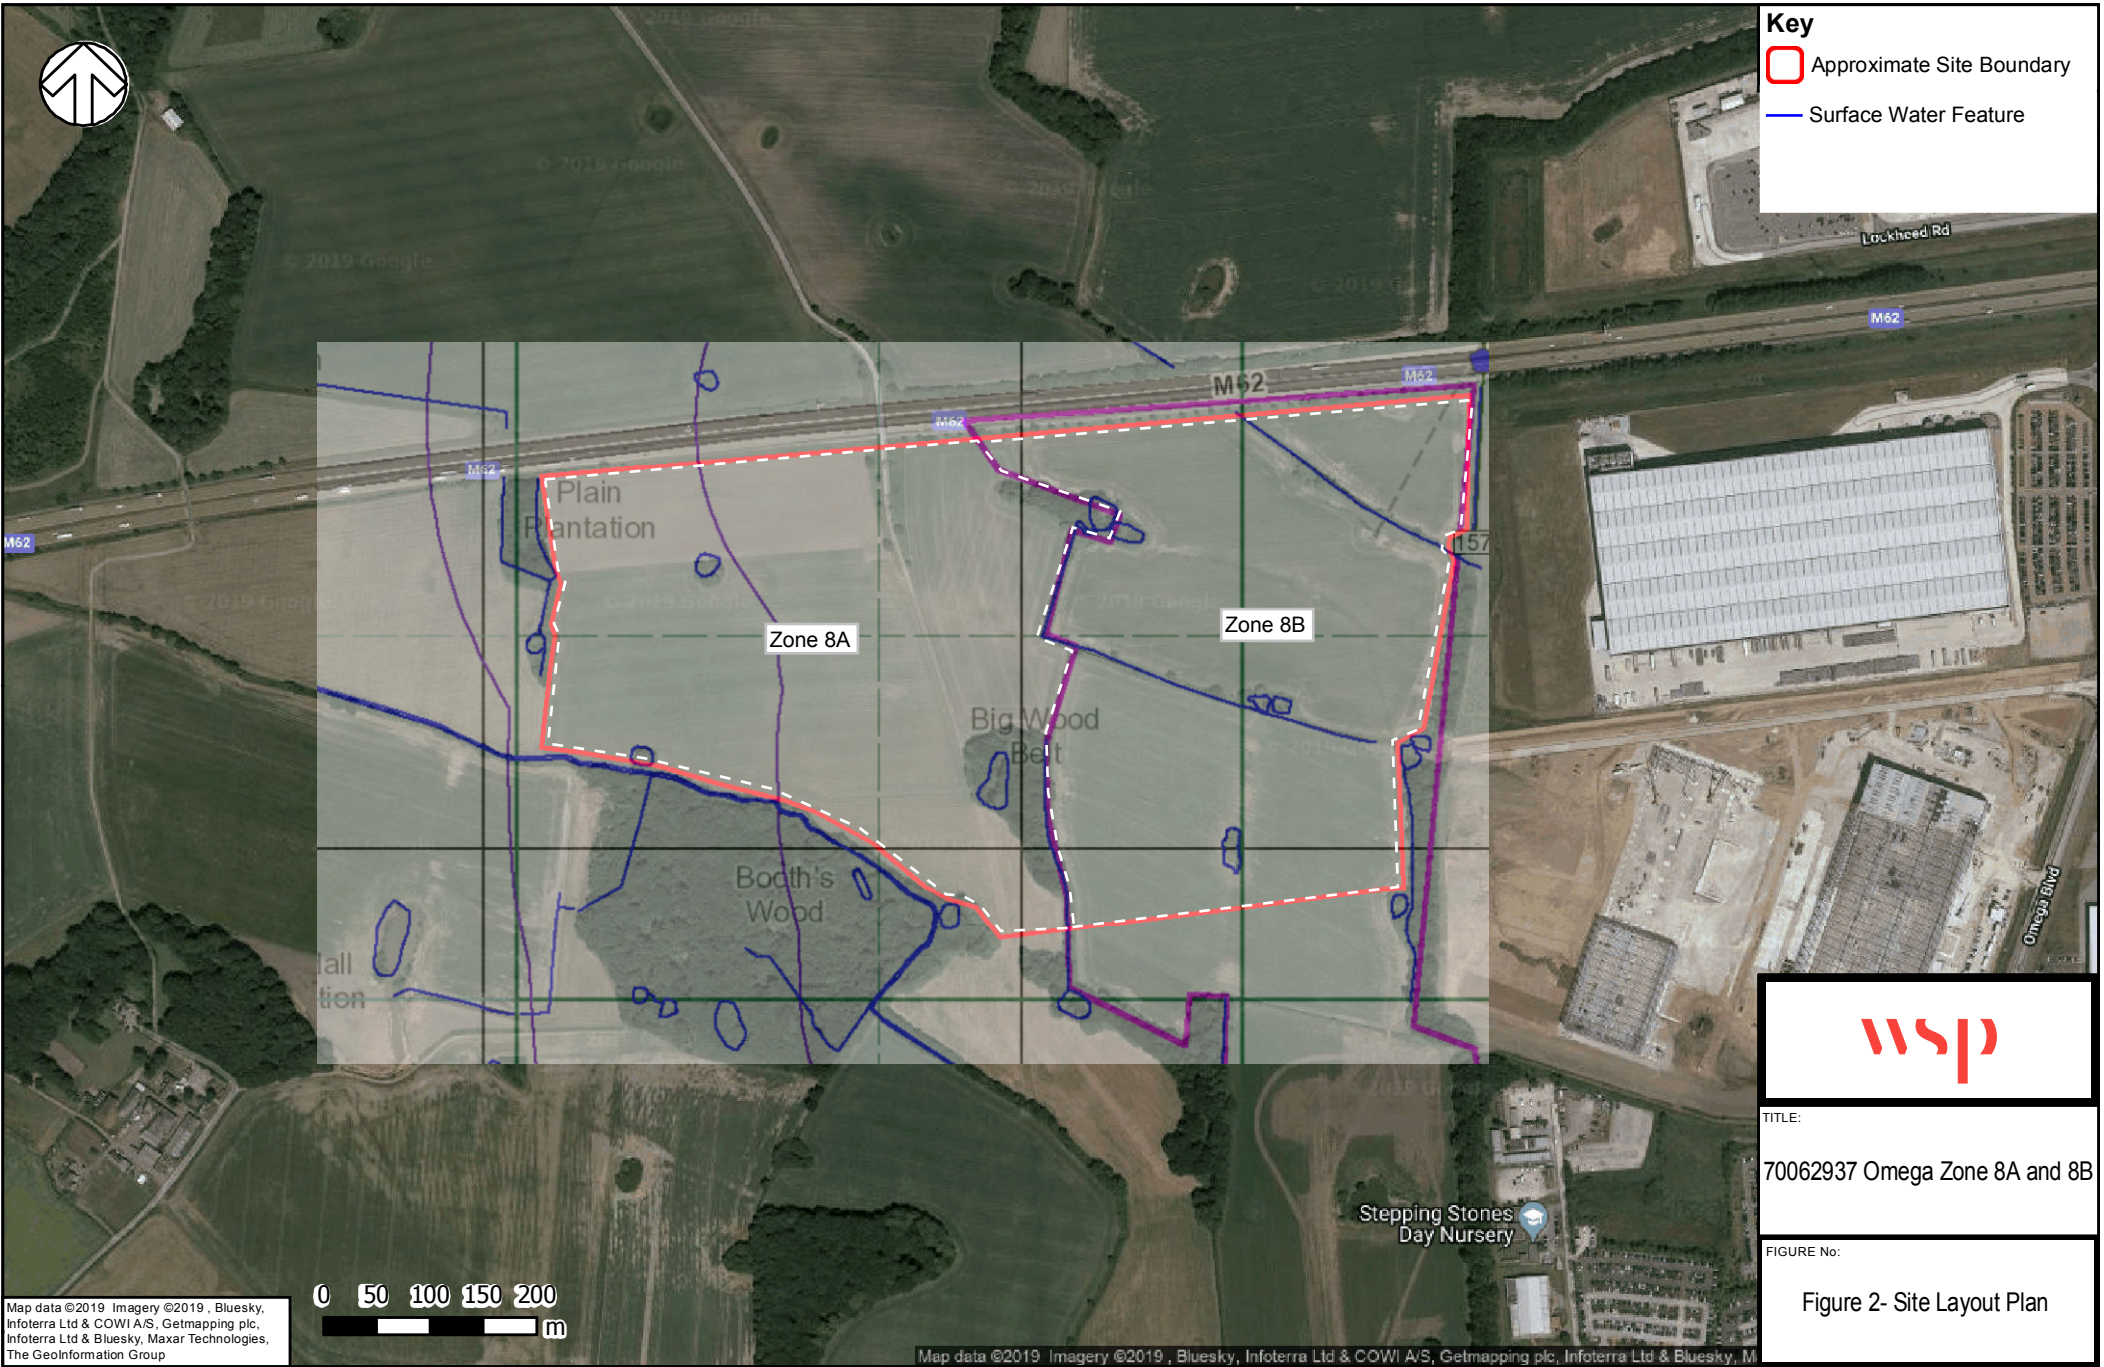
Exploratory Hole Location Plan

- Legend**
- Zone 8 Site Boundary
  - Cone Penetration Test - Pressuremeter Test
  - Cable Percussion / Rotary Follow on
  - Window Sampler
  - Cone Penetration Test
  - Trial Pit

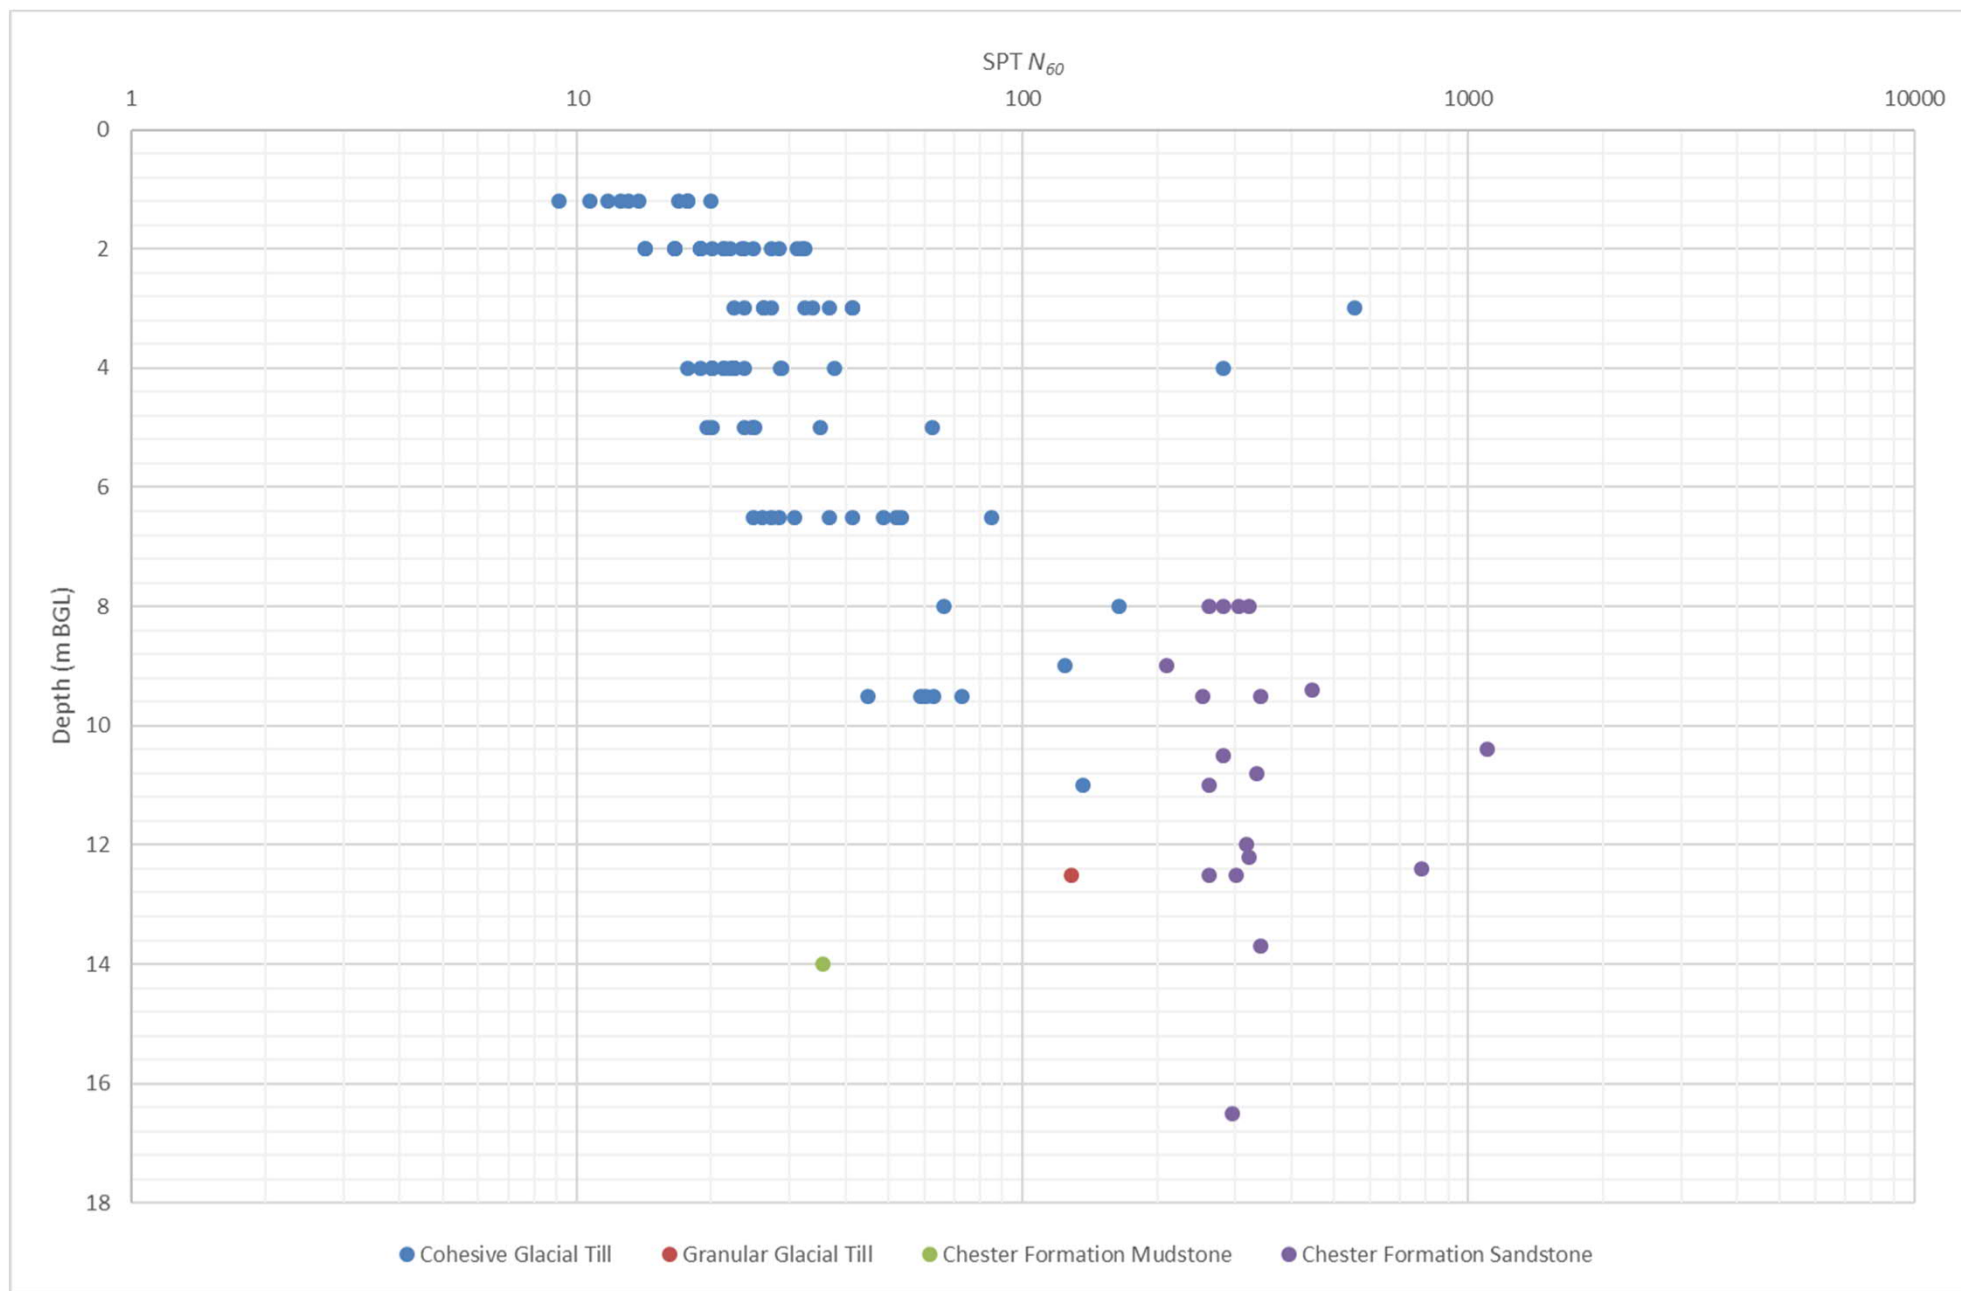
| Date | December 2019 | Figure No. | A.1 |

| Title | SPT $N_{60}$ vs Depth | Checked by | MN |

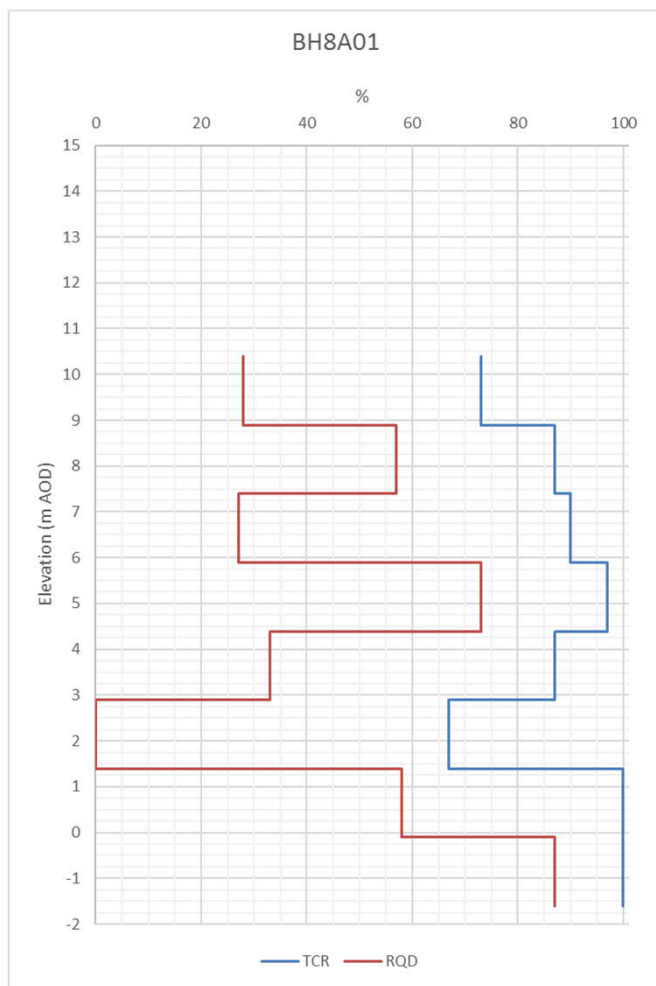
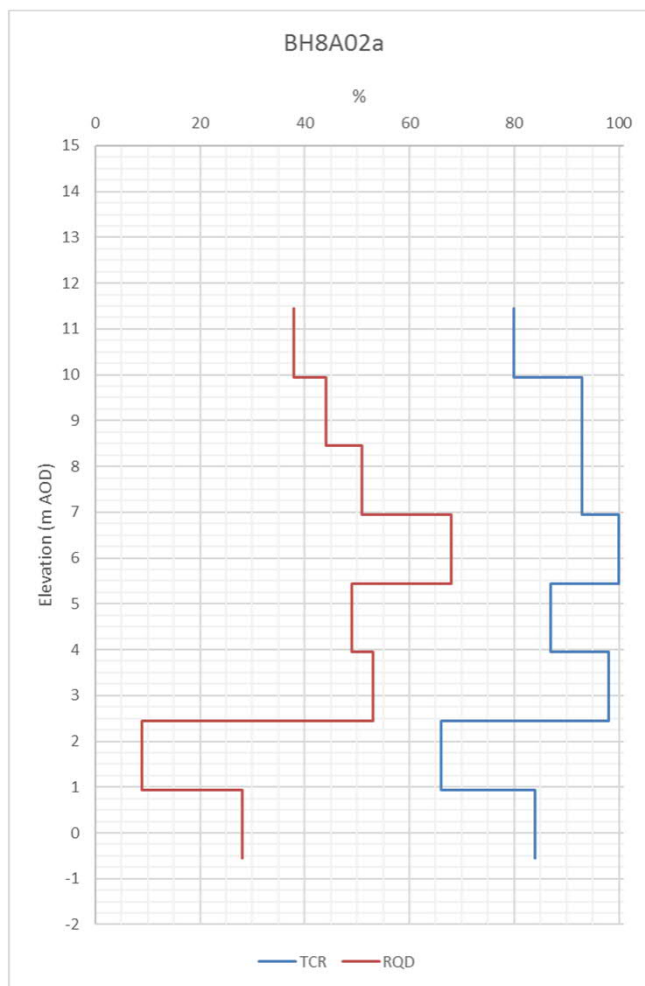
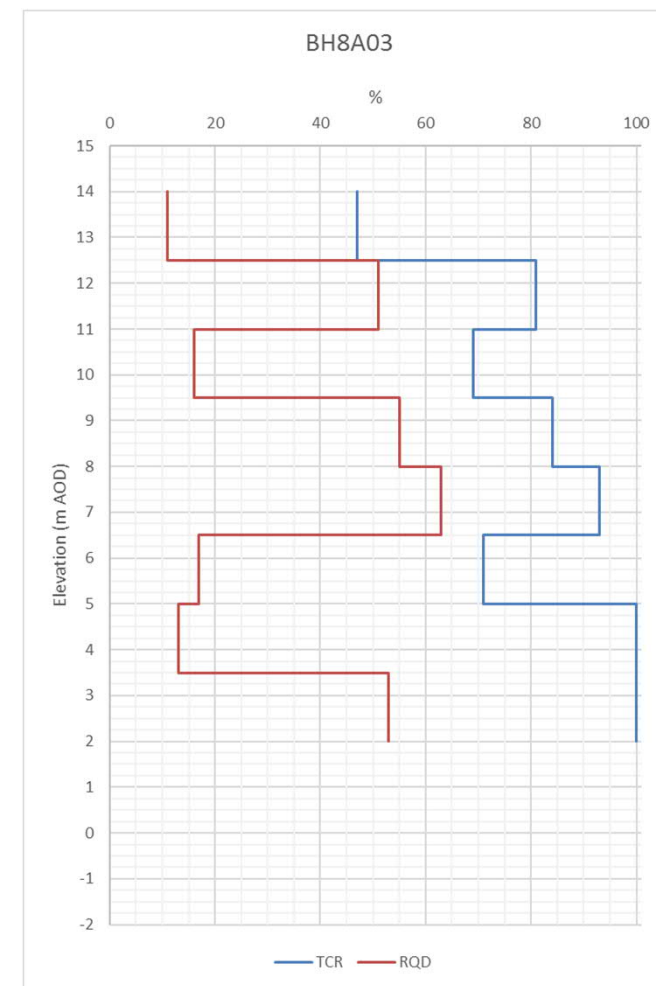
| Date | December 2019 | Figure No. | A.2 |

| Title | Total Core Recovery & Rock Quality Designation – BH8A01, BH8A02, & BH8A03 | Checked by | MN |

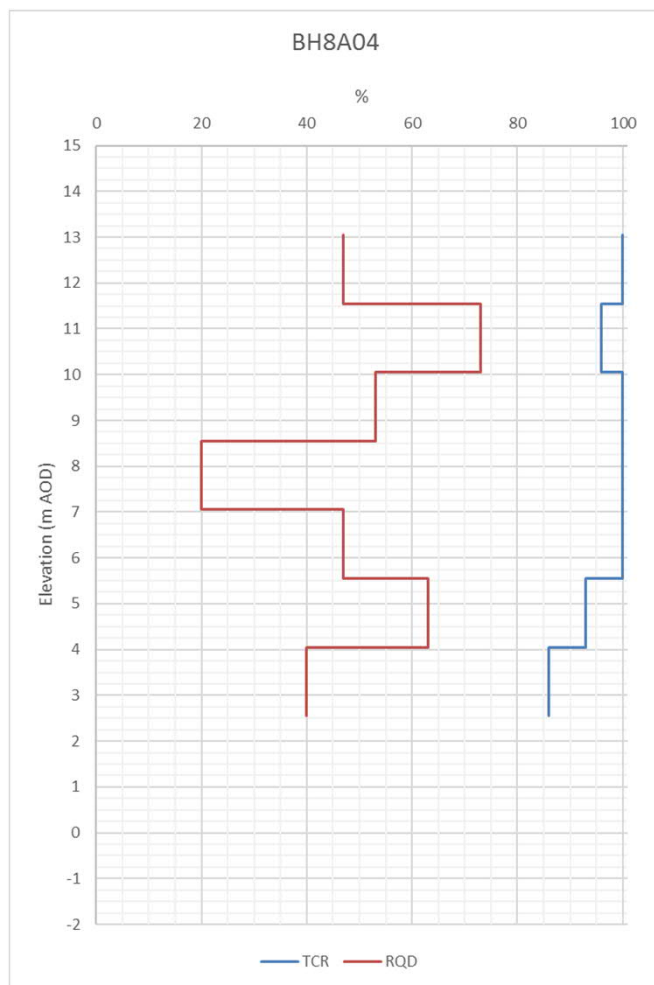
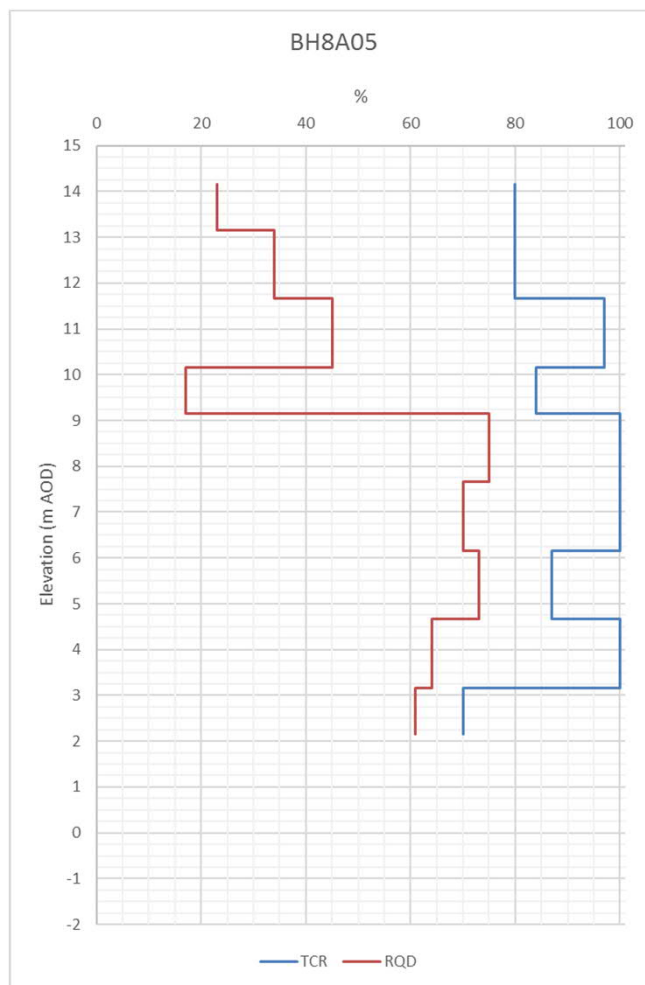
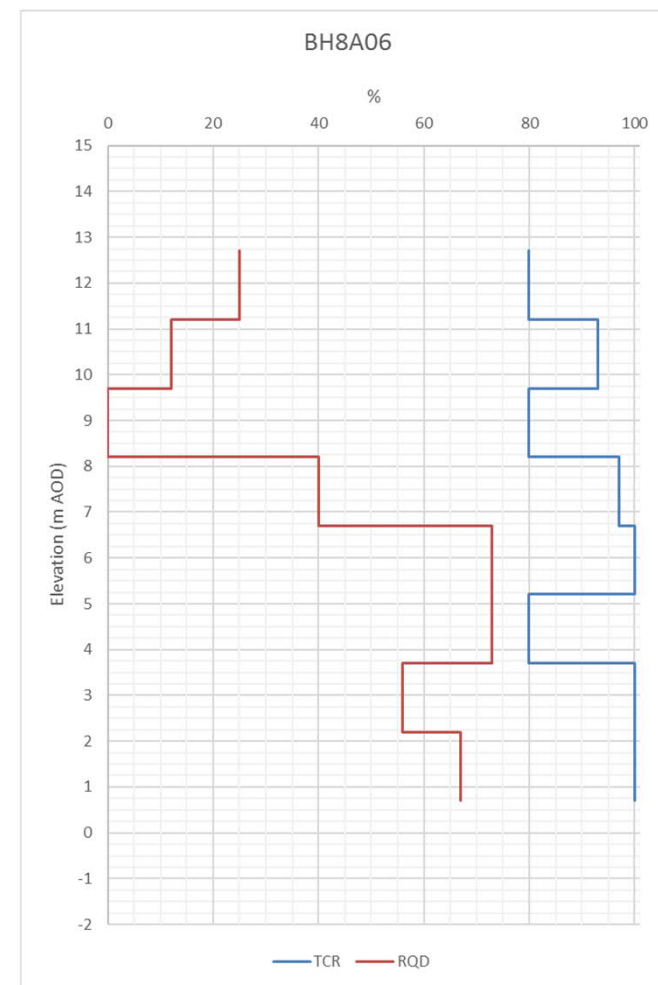
| Date | December 2019 | Figure No. | A.3 |

| Title | Total Core Recovery & Rock Quality Designation – BH8A04, BH8A05, & BH8A06 | Checked by | MN |

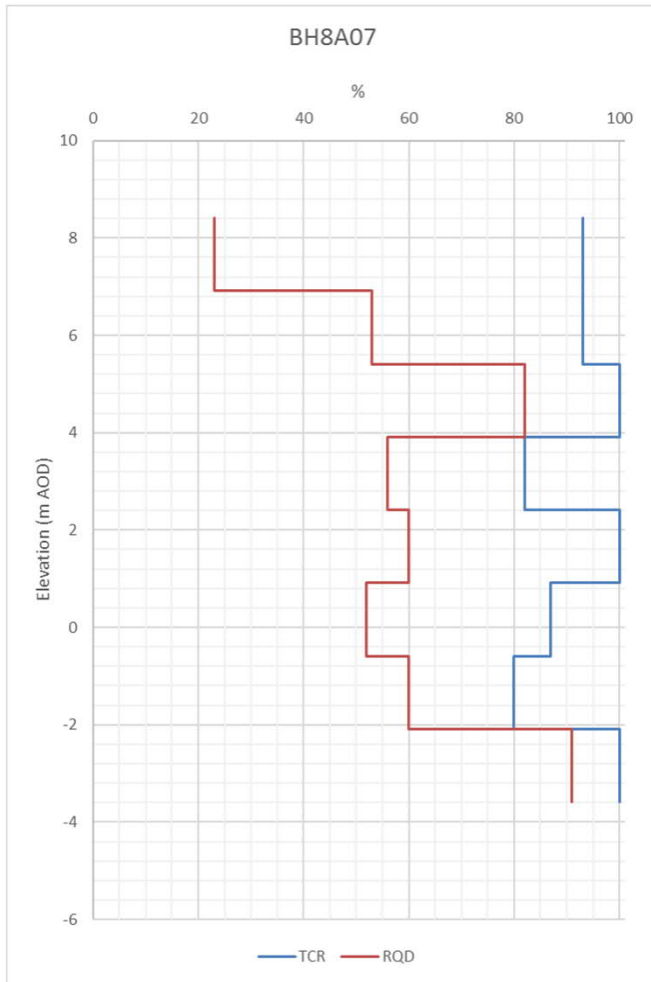
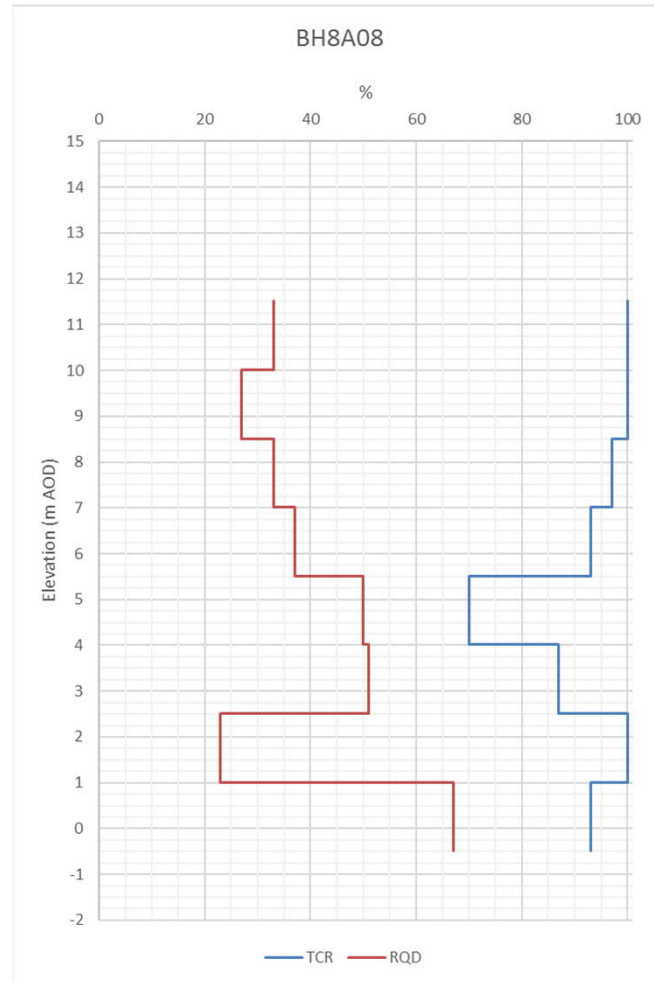
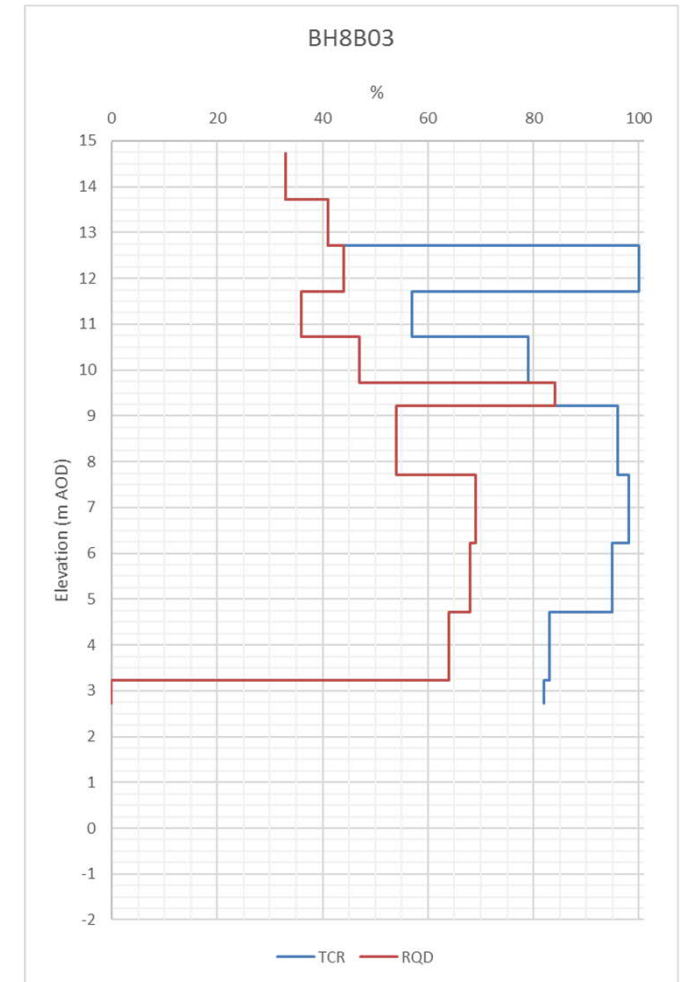
| Date | December 2019 | Figure No. | A.4 |

| Title | Total Core Recovery & Rock Quality Designation – BH8A07, BH8A08, & BH8B03 | Checked by | MN |
